Ecological Surveys of Welsh Lakes 2015

Goldsmith, B., Turner, S., Shilland, E. and Goodrich, S. ENSIS Ltd. London

NRW Evidence Report No. 145

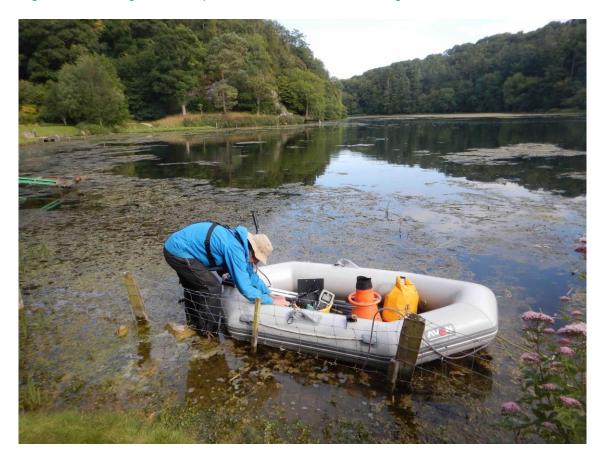
Figure 3 Ysceifiog Lake site photo; from west shore looking east

Ysceifiog Lake is a small (6 ha), very shallow (max. depth 3.0 m) lowland lake located on alkaline geology in Flintshire, North Wales. The site is surrounded by mixed woodland. The aquatic macrophytes flora was dominated by a mixed mosaic of species that are most typical of eutrophic waters (Table 3).

Of particular interest at Ysceifiog Lake is the extensive cover of Water violet *Hottonia palustris*; a species more commonly found in very small ponds and ditches (Preston & Croft 1997). This species probably benefits from the shelter afforded by the surrounding woodland. Although maintaining a relatively species rich flora, the site lacks any broad-leaf *Potamogeton* species and the high abundance of *Fontinalis antipyretica* and *Ceratophyllum demersum* and presence of *Enteromorpha* sp. suggests the site to suffer from eutrophication. At the time of survey, the water was well oxygenated throughout the water column (Figure 4).

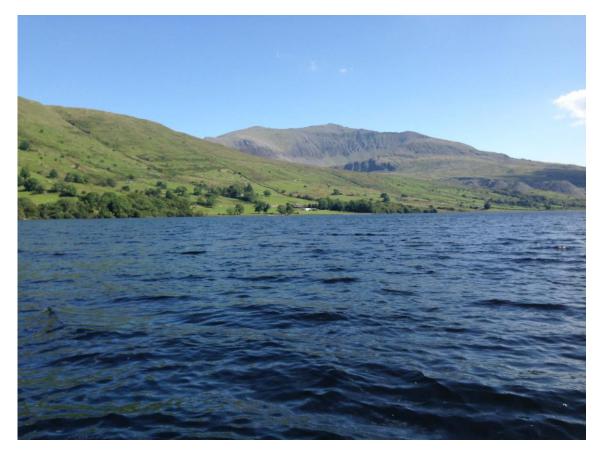
Figure 6 Llyn Cwellyn site photo; looking east towards Snowdon

The aquatic macrophyte flora is typical of low alkalinity, clear water lakes with extensive populations of *Littorella uniflora, Lobelia dortmanna* and *Isoetes lacustris* forming overlapping zones to a depths of up to 5.3 m (Table 4). In additional and of particular interest to the SAC feature is the population of Floating water plantain *Luronium natans.* This species is not particularly well represented within the CSM sections, but we know from a recent snorkel survey of the site conducted by ENSIS (Goldsmith *et al.* 2014a) that it occurs in at least three separate populations within the site (Figure 7). The current species assemblage would place the site in favourable condition with respect to its flora under JNCC CSM Guidelines (JNCC 2015)

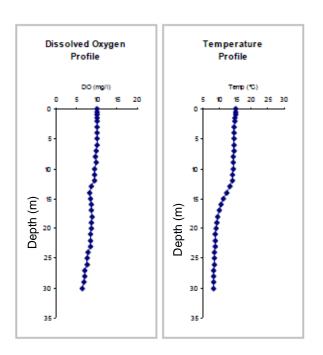
Dissolved Oxygen Profile

GPS Location Maximum Depi Secchi Depth (Notes:	SH5554455222 35.6 m 510 cm	
Depth (m)	DO (mg/l)	Temp (°C)
0	10.14	15.1
0.5	10.16	15.1
1	10.07	15
1.5	10.11	14.9
2	10.07	14.8
3	10.1	14.7
4	10.05	14.7
5	10.04	14.7
6	10	14.6
7	9.9	14.5
8	9.77	14.4
9	9.81	14.3
10	9.53	14.3
11	9.54	14.1
12	9.5	14.1
13	8.63	13.3
14	8.35	12.2
15	8.45	11.2
16	8.63	10.6
17	8.75	10
18	8.85	9.5
19	8.75	9.2
20	8.78	9.1
21	8.49	8.9
22	8.49	8.8
23	8.41	8.7
24	7.91	8.6
25	7.72	8.5
26	7.7	8.5
27	7.17	8.4
28	7.1	8.4
29	6.91	8.4
30	6.48	8.4

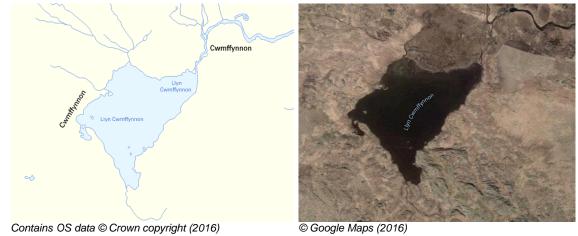
Figure 9 Site map and aerial photograph of Llyn Cwmffynnon

Llyn Cwmffynnon is a relatively shallow (max. recorded depth 10.1 m) oligotrophic lake situated at an altitude of 358 m below the Glyder mountains in Gwynedd. The site forms part of the Eryri / Snowdonia SAC and is within the Snowdonia National Park. Llyn Cwmffynnon has a relatively small catchment area (c. 80 ha) dominated by acid heath and acid grassland. Palaeoecological evidence from the site suggests it to have acidified (Goldsmith *et al.* 2006), which is typical for poorly buffered sites in this region.

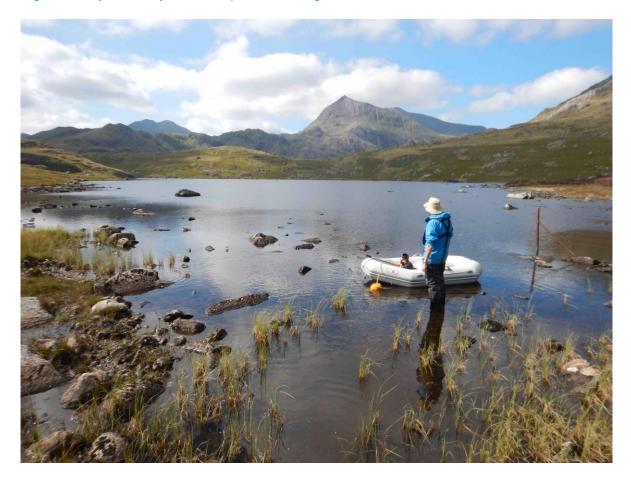
Figure 10 Llyn Cwmffynnon site photo; looking west towards Snowdon

The aquatic macrophyte flora is typical of a low alkalinity, oligotrophic lake with minor humic influence (Table 5). *Littorella uniflora, Lobelia dortmanna* and *Isoetes lacustris* are abundant throughout much of the littoral zone, with *I. lacustris* reaching a maximum depth of 3.5 m and *Nitella flexilis* agg. extending slightly deeper to 3.9 m. The maximum depth of colonisation appears limited by the slightly brown water draining from the overlying peat in the catchment. Other characteristic oligotrophic species present were *Utricularia vulgaris* agg. and *Elatine hexandra,* the latter possibly being a new record for the site. The current survey did not record *Sparganium angustifolium,* which has in the past been present, albeit relatively rare in the site. The current species assemblage would place the site in favourable condition with respect to its flora under JNCC CSM guidelines (JNCC 2015), but the possible loss of a characteristic species (*S. angustifolium*) requires further investigation and evidence from previous palaeoecological work suggests the lake to be impacted by acidification.

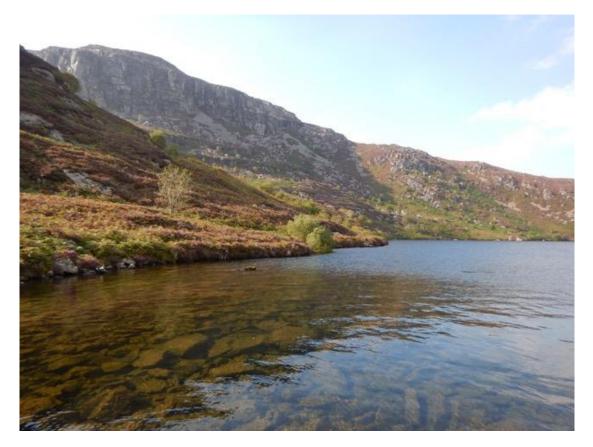
Figure 13 Llyn Arenig Fawr site photo; looking northwest towards Arenig Fawr peak

Llyn Arenig Fawr is a deep (max. recorded depth 35.5 m) oligotrophic lake situated at an altitude of 405 m and lying below the peak of Arenig Fawr to the west of Bala in Gwynedd. The lake level was raised in the nineteenth century and altered again in the twentieth century to provide potable water to Bala. Llyn Arenig Fawr forms part of the Migneint–Arenig–Dduallt SAC and is a WDF Operational site. The relatively small catchment (c. 154 ha) is dominated by acid heath and upland acid grassland. The low alkalinity (10 μ Eql-1, CEH 2016) indicates that the lake is poorly buffered and likely to have been susceptible to acidification.

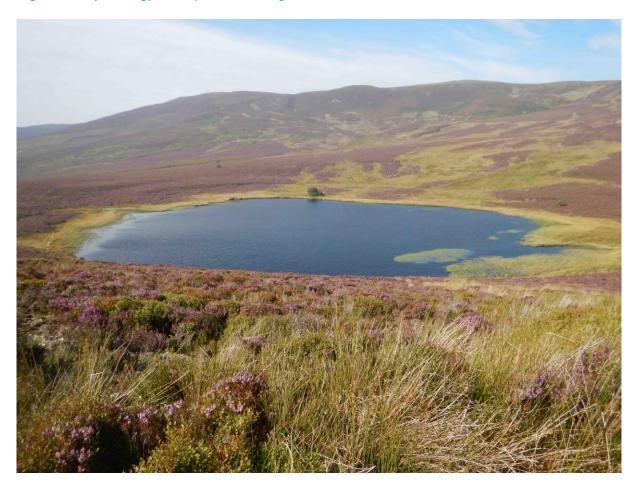
Figure 16 Llyn Hesgyn site photo; looking southwest

Llyn Hesgyn is a shallow (max. recorded depth 5.2 m) oligotrophic lake situated at an altitude of 425 m to the east of Carnedd y Filias (669 m) in Gwynedd. The lake forms part of the Migneint-Arenig-Dduallt SAC and is within the Snowdonia National Park. Llyn Hesgyn drains an area to the north (c. 170 ha) dominated by acid heath and grassland. Palaeoecological evidence from the site suggests it to have remained relatively stable in terms of acidification (Goldsmith *et al.* 2006), and water chemistry from the site suggests it to have adequate buffering (Carvalho *et al.* 2003, Goldsmith *et al.* 2006). Although the lake is classified as being Oligotrophic within the HD typology, it shows strong influences from the peat in the catchment and has very brown water and relatively high DOC (Goldsmith *et al.* 2006). The Secchi depth in September 2015 was only 85 cm due to the brown colour of the water. This is contrasts with 1.7 m in August 2002 (Carvalho *et al.* 2003) and 1.0 m in 2004 (Goldsmith *et al.* 2006).

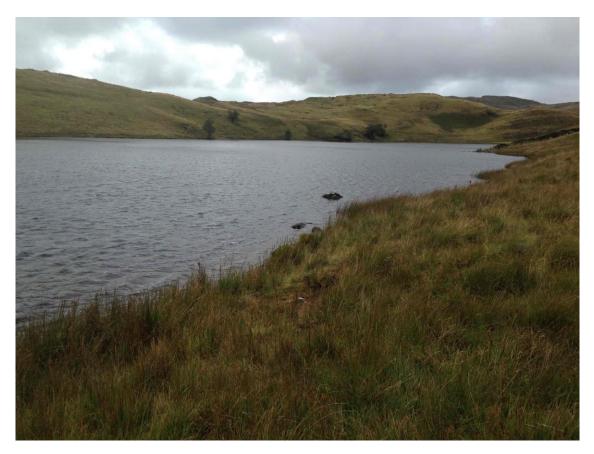
Figure 19 Llyn Hiraethlyn site photo; from the southeast shore looking northwest

Llyn Hiraethlyn has a typical aquatic macrophyte flora for a low alkalinity, oligotrophic lake (Table 8). *Isoetes lacustris, Littorella uniflora* and *Lobelia dortmanna* and present at increasing abundance and the site supports a small but apparently stable population of *Luronium natans*. Of possible concern is an areas where *Juncus*

bulbosus occurs at high abundance (mainly restricted to the north end) which can be indicative on increased nutrients. Past surveys (e.g. Carvalho *et al.* 2003) have recorded *Isoetes echinospora* at the site, but all fertile material examined in 2015 was confirmed as *I. lacustris.*

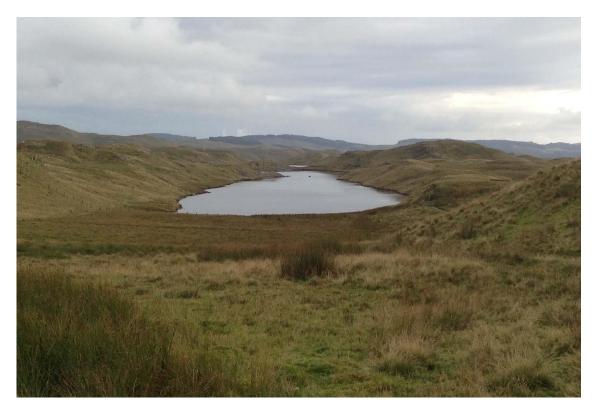
Figure 28 Llyn Hîr site photo; from the southeast shore looking northwest

Llyn Hîr is a relatively shallow (max. recorded depth 7.9 m) oligotrophic lake situated within the Tiefi Pools at an altitude of 439 m in Ceredigion. The site lies within the headwaters of the Afon Teifi / River Teifi SAC and is a WFD Surveillance site. The

lake has a relatively small catchment area (c. 21 ha) dominated by acid grassland and small areas of acid heathland. Palaeoecological evidence from the site shows it to have undergone significant change due to acidification over the past 150 years (Battarbee *et al.* 1988, Goldsmith *et al.* 2006). Such was the extent of acidification that in 1985 the Welsh Water Authority limed Llyn Hîr, elevating the pH from 4.8 to current levels of approximately 6.4 (Goldsmith *et al.* 2006).

Luronium natans and *Subularia aquatica*. The current species assemblage would place the site in favourable condition with respect to its flora under JNCC CSM Guidelines (JNCC 2015). The longer-term impact of liming the site is of interest and would warrant further palaecological investigation.

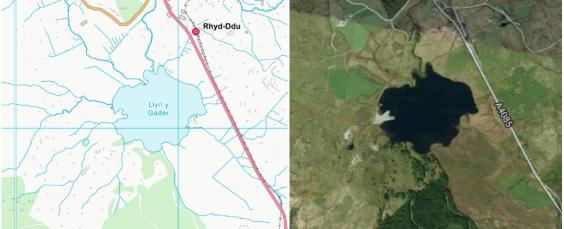
Figure 30 Site map and aerial photograph of Llyn y Gader

The aquatic macrophytes flora of Llyn y Gader is exceptional. The site has a very species rich assemblage of typical, clear-water, oligotrophic species (Table 12). There are extensive populations of *Littorella uniflora, Lobelia dortmanna* and *Isoetes lacustris* forming overlapping zones throughout the lake to maximum depth. In additional and of particular interest to the SSSI / SAC feature is the population of Floating water plantain *Luronium natans* which occurs throughout the lake from the sheltered margins, growing within *Carex rostrata* beds, to a maximum depth of 2.0 m. It was most abundant within the 1-1.8 m depth zone and present in a total of 33% of the survey points (58% of open water points). Other species of note included *Pilularia globulifera* which was recorded as two separate populations in shallow water, and three species of *Nitella* with Llyn y Gader being a new site for *N. gracilis* (N. Stewart, *pers. comm.*). *Juncus bulbosus* was recorded at high frequency (and abundance) which may be indicative of enrichment and therefore we would recommend that water quality monitoring be carried out at the site. The current species assemblage

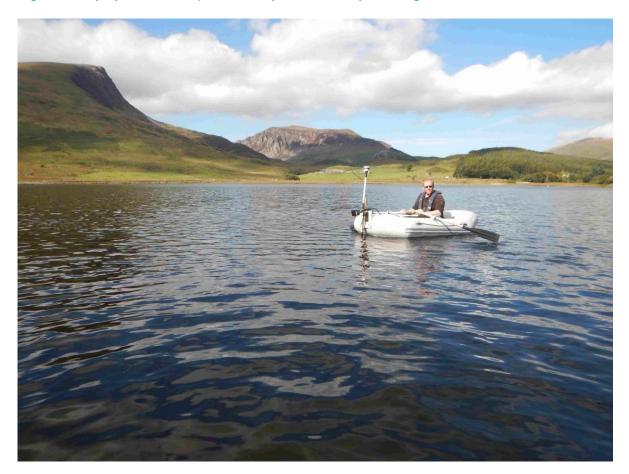
Figure 31 Llyn y Gader site photo; bathymetric survey, looking northeast towards Snowdon

would place the site in favourable condition with respect to its flora under JNCC CSM Guidelines (JNCC 2015).

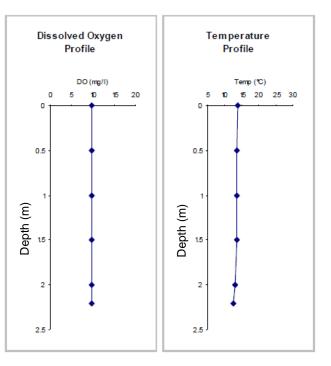
GPS LocationSH5681152034Maximum Depth (m)2.3 mSecchi Depth (cm)-Notes:Water clear and secchi > max depth

Depth (m)	DO (mg/l)	Temp (°C)
0	9.74	13.7
0.5	9.69	13.6
1	9.64	13.6
1.5	9.64	13.5
2	9.76	12.9
2.2	9.79	12.6

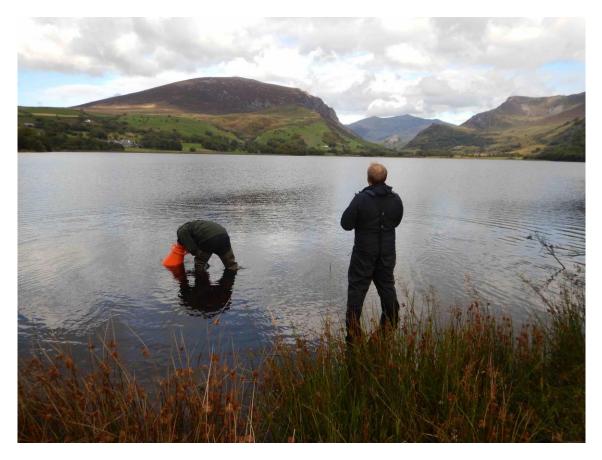
Figure 34 Llyn Nantlle Uchaf site photo; macrophyte survey, looking east towards Snowdon

The aquatic macrophytes flora of Llyn Nantlle is of considerable interest. The site is relatively species rich and dominated by species typical of clear-water, oligotrophic lakes (Table 13). There are typical zone with *Littorella uniflora, Lobelia dortmanna* (occasion) and *Isoetes* spp. to a depth of 2.0 m. Based on vegetative characters, it is probable that both *Isoetes lacustris* and *I. echinospora* are present in the lake, but only the latter was confirmed from the voucher specimens collected. A more comprehensive study of the *Isoetes* plants is therefore required to confirm if both are present and the proportion at which they occur.

site in favourable condition with respect to its flora under JNCC CSM Guidelines (JNCC 2015), but "at risk" based on the presence of *Elodea canadensis*.

We recommend that this site should be afforded greater protection based on the extensive population of *L. natans* (well established, historic and healthy), in conjunction with a mixed oligotrophic flora containing *Isoetes echinospora* and *Elatine hydropiper*.

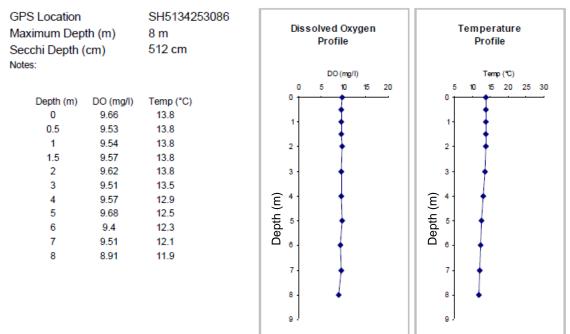
Figure 35 Dissolved oxygen and temperature profiles at Llyn Nantlle (17/09/2015)

Being very shallow, the dissolved oxygen and temperature profiles show the lake to be well mixed with good oxygen concentration throughout the water column (Figure 35).

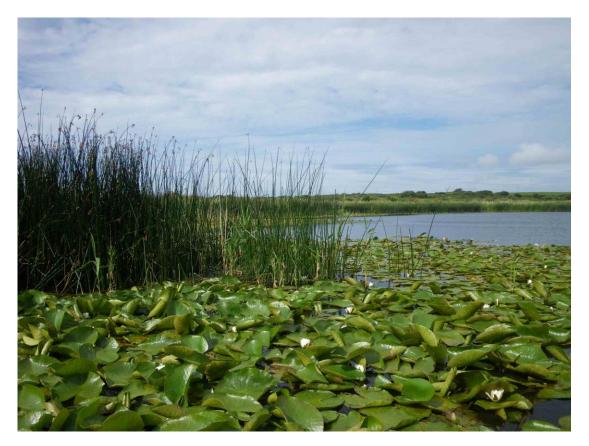
Figure 37 Lyn Dinam site photo; typical marginal zone (southeast shore)

Llyn Dinam is a very shallow (1.9 m), naturally eutrophic lake lying 1.5 km from the coast of western Anglesey within the Llynnau y Fali: Valley Lakes SSSI and Llyn Dinam SAC. The site is reed fringed around most of its margin and the wider catchment comprises a mix of a neutral to alkaline grassland with some improved

Although maintaining a relatively species rich flora, the site is dominated by *Ceratophyllum demersum* and lacks the abundance of broad-leaf *Potamogeton* species one expects to see in natural eutrophic sites in favourable condition. A few plants of *P. crispus* were recorded along with one record for *P. perfoliatus*. The current species assemblage is borderline favourable with respect to CSM guidelines (JNCC 2015), but water quality has previously failed to meet CSM targets (Mean TP 58 µgl-1 in 2003-4) and water clarity was very poor in July 2015 (Secchi = 75 cm).

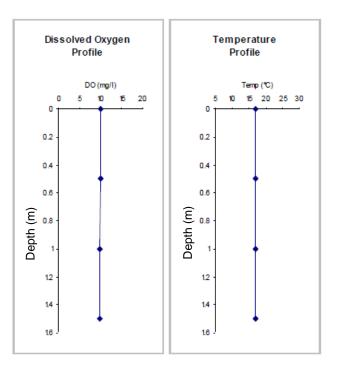
GPS Location	
Maximum Depth (m)	1.85 m
Secchi Depth (cm)	75 cm
Notes:

Depth (m)	DO (mg/l)	Temp (°C)
0	10	16.9
0.5	10.1	16.9
1	9.7	16.9
1.5	9.7	16.9

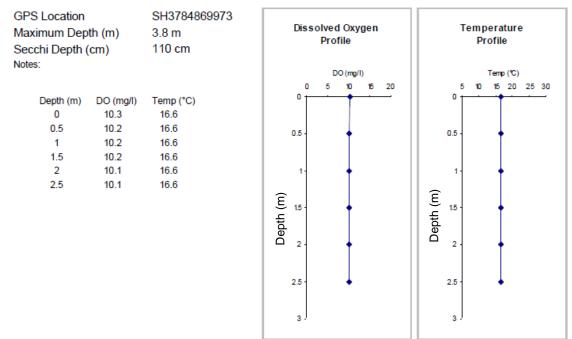
Figure 41 Dissolved oxygen and temperature profiles at Llyn Coron (01/08/2016)

The site is very shallow and exposed and at the time of survey the water was well oxygenated (Figure 41).

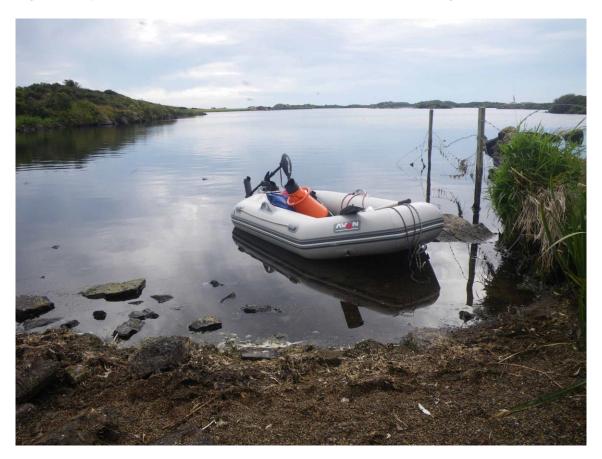
Figure 43 Lyn Traffwll site photo; taken from the north shore looking south

Llyn Traffwll is a relatively large, base rich, shallow (max. recorded depth 4.1 m) lake lying within the Crigyll catchment. The lake is close to the Valley Lakes SSSI just to the west, but is separated from Llyn Penrhyn by a low ridge on which the village of Llanfihangel yn Nhowyn is located. The entire lake and associated wetland to the south-west and outflow to the south is designated as a SSSI on the basis of biological interest with eight-stamened waterwort (*Elatine hydropiper*) and flowering rush (*Butomus umbelatus*) being of particular interest. The lake is also notable as important site for overwintering wildfowl, particularly shoveler, but also gadwall, widgeon, pochard and goldeneye. The wider catchment extends to the north of the site and comprises approximately 65% improved grassland, with areas of unimproved calcareous grassland (UK Lakes CEH 2016).

The aquatic macrophyte flora is relatively rich, with 17 species recorded, most of which are typical of eutrophic waters (Table 16). Of particular interest is the high frequency of *Elatine hydropiper* which was common in the littoral zone to 1.2 m and also the presence of *Littorella uniflora*, which although not recorded in the transects has been recorded previously in the site (Goldsmith *et al.* 2014b) and was found in the strandline of the current survey. The current species assemblage does not meet the target criteria for favourable condition as set out in the CSM guidelines (JNCC 2015).

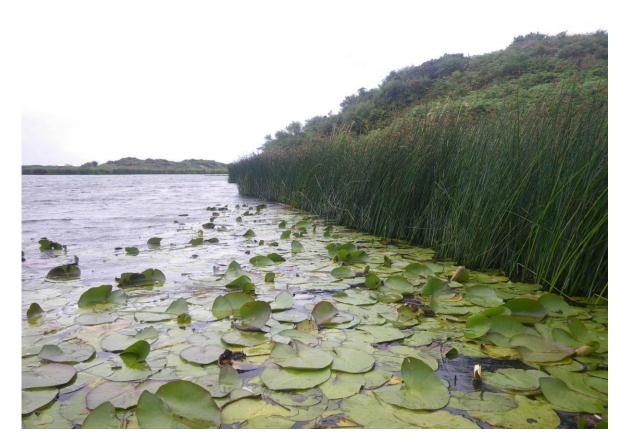
Figure 46 Lyn Penrhyn site photo; typical marginal zone (southwest shore)

Llyn Penrhyn is a very shallow (max. recorded depth 2.7 m), naturally eutrophic lake lying 1.5 km from the coast of southwest Anglesey and within the Llynnau y Fali: Valley Lakes SSSI. The site is reed fringed around most of its margin and the wider

The current aquatic flora is sparse and with *Ceratophyllum demersum* most frequently occurring species. The site fails to meet the target of six characteristic species required for favourable condition within the CSM guidance (JNCC 2015) and also lacks the abundance of broad-leaf *Potamogeton* species one expects to see in natural eutrophic sites (and appears to have lost *P. lucens*). The current species assemblage is therefore unfavourable and suggests the site to remain hyper-eutrophic.

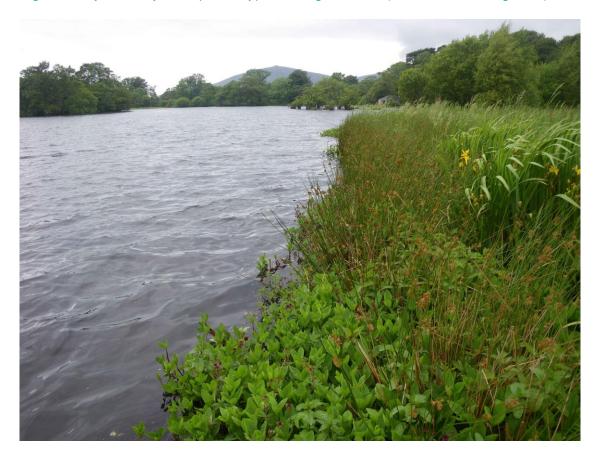
Figure 49 Lyn Glasfryn site photo; typical marginal zone (east shore looking west)

Although the lake has continued to support a relatively diverse flora in recent years, including notable rarities such as *Elatine hydropiper* and *E. hexandra*, there have been no records of *Luronium natans* since 1987 (Lockton 2009) and the site no longer supports the isoetid flora that is characteristic of many mesotrophic lakes. Seddon (1972) reports the presence of *Littorella uniflora, Isoetes echinospora* and even *Subularia aquatica* from surveys conducted in the early 1960s, although *Luronium natans* was not recorded at that time.

The current aquatic flora is more typical of eutrophic waters than the mesotrophic features for which the site was designated and fails to meet the characteristic species targets required for favourable condition within the CSM guidance (JNCC 2015). The site is clearly very dynamic with respect to its flora and would therefore benefit from annual surveys to better understand it ecological function.

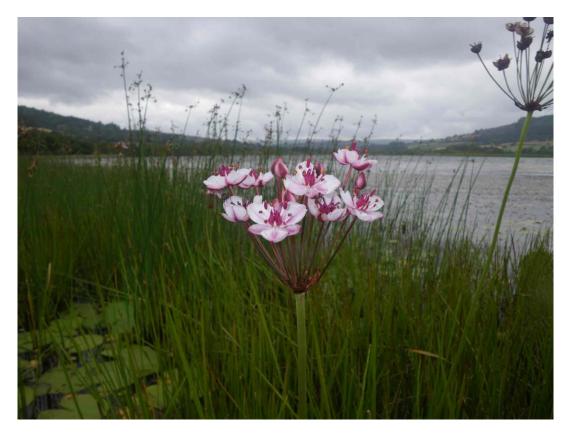
Figure 52 Llangorse Lake site photo; from northeast shore looking south (*Butomus umbellatus* flowering)

Llangorse Lake is a large (140 ha), shallow (max. recorded depth 7.5 m) lowland lake located on alkaline geology in Powys, south Wales. The site was designated as a SSSI in 1954 and is a HD Annex I site (SAC) for its Natural Eutrophic lake feature. The lake is surrounded by a variety of habitats including wet, broadleaf and mixed woodland and improved grassland and the wider catchment is dominated by improved grassland.

The current flora, although greatly improved since the site was grossly polluted in the 1970s and now with a number of notable elements, remains unfavourable with respect to the CSM targets (JNCC 2015). The site having only five characteristic eutrophic species and an abundance of *Elodea* spp. being the primary reason for failure.

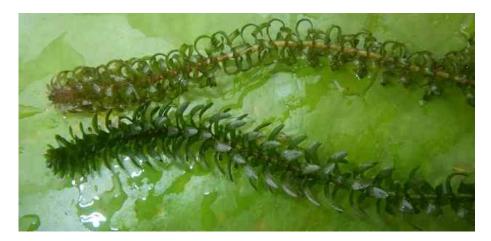
Figure 53 Elodea nuttallii (top) and E. canadensis (below) from Llangorse Lake

Despite the dominance of *Elodea* spp. in the site, the overall species richness was high and included five characteristic eutrophic species (JNCC 2015). Notable species included *Potamogeton lucens* (Figure 55) which appears relatively stable at the site since 2003 ranging in frequency from 6.7 – 19.6 % (based on 6 surveys by ENSIS). *Chara globularis* was present in three transects and mainly occurring at depths of 1-1.5 m. *Spirodela polyrhiza* was frequent within the sheltered marginal areas, mainly restricted to areas within the reeds. A single record of *Nitellopsis obtusa* was recorded from 1.9 m water depth at (SO1295526348). This stonewort species was first detected in Llangorse Lake in 2014 (N. Stewart, *pers. comm.*); it is classified as endangered (IUCN) and is a BAP priority species and NERC Species of Principal Importance in Wales. Its presence in the site should therefore be monitored and it should be included in any future conservation strategy at the site.

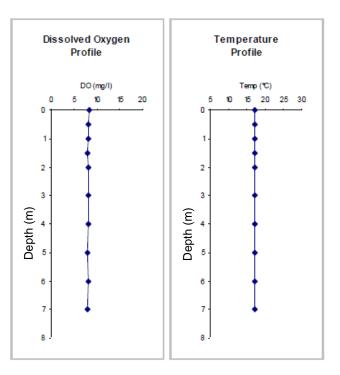
GPS Location	SO1341826623
Maximum Depth (m)	7.3 m
Secchi Depth (cm)	120 cm
Notes:

Depth (m)	DO (mg/l)	Temp (°C)
0	8.31	17.1
0.5	8.17	17.1
1	8.17	17.1
1.5	8.04	17.1
2	8.1	17.1
3	8.08	17.1
4	8.16	17.1
5	8.04	17.1
6	8.2	17.1
7	7.93	17.1

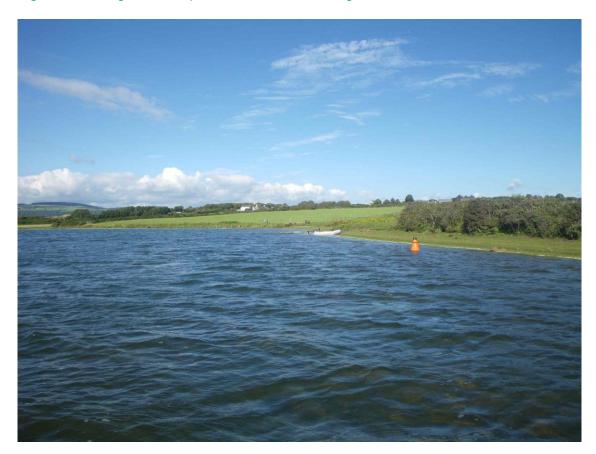
Figure 57 Kenfig Pool site photo; east shore looking north

Kenfig Pool is a very shallow (2.4 m) lake situated towards the landward side of the Kenfig Burrows in Bridgend, South Wales. The area was designated as a SSSI in 1953 and Kenfig Pool forms part of the Kenfig SAC and is designated as a lake with "Hard oligo-mesotrophic waters with benthic vegetation of Chara spp.". The surface water catchment of the lake is relatively small and comprises improved grassland and sand dunes as well as the urban area of Kenfig village to the east of the site..

This site is atypical for of its HD designation as a hard water lake. The current flora fails to reach the CSM targets for favourable condition with respect to its flora under JNCC CSM Guidelines (JNCC 2015). The dominance of *C. demersum* in 2015 is of concern and we would recommend regular monitoring of the flora and water quality to help inform site management.

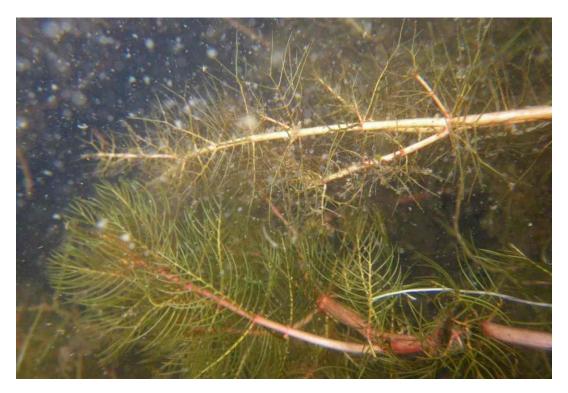
Figure 58 Myriophyllum alterniflorum (top) and M. spicatum (below) in Kenfig Pool

The site is notable for supporting six *Potamogeton* species and one hybrid (Table 20). *Potamogeton gramineus* and its *P. lucens* hybrid (*P. x angustifolius*) are mainly confined to the sheltered areas at the back of the reed fringed north shore; the small bay at the northern extent of the lake being particularly rich. *Littorella uniflora* is locally abundant in the sandy substrates along the north shore and occasional just above the waterline where it was seen in flower. Kenfig Pool is rather unusual in that it supports both *Myriophyllum spicatum* and *M. alterniflorum* (Figure 58). These two species are normally ecologically distinct, with the latter favouring more oligotrophic, low alkalinity sites and *M. spicatum* being a typical eutrophic species of more alkaline waters.

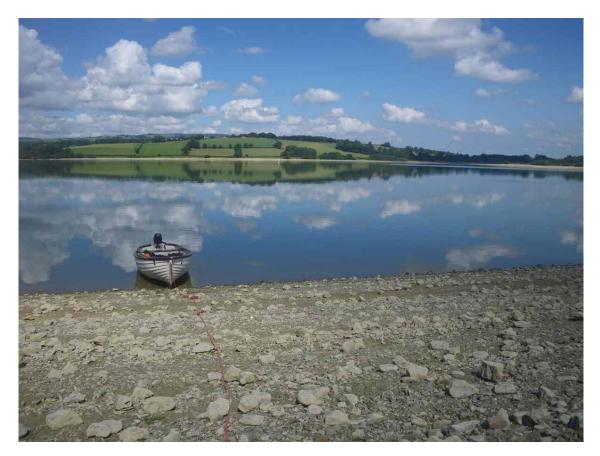
Figure 61 Llandegfedd Reservoir site photo; southeast shore looking northwest

In August 2015, Llandegfedd reservoir was drawn down by approximately 3.8 m and as a consequence there was almost no submerged aquatic flora present in the site. In 2012, an ENSIS survey showed the site to support *Chara globularis, Persicaria amphibia, Ranunculus aquatilis, Potamogeton pusillus* and *Zannichellia palustris* after a prolonged period without any major draw-down. In 2015, only *Z. palustris* was recorded growing in one small area of the reservoir, and a single plant of *Potamogeton pectinatus* was recorded from the strandline.

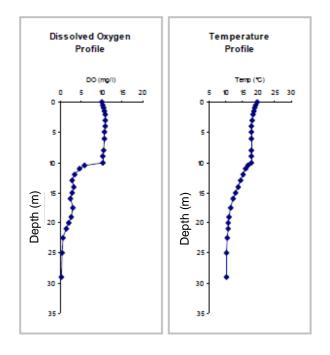
Dissolved Oxygen Profile

GPS Location Maximum Dep	th (m)	ST3257698756 30.3 m
Secchi Depth ((cm)	195 cm
Notes:		
Depth (m)	DO (mg/l)	Temp (°C)
0	10.2	19.6
0.5	10.32	19.2
1	10.53	18.8
1.5	10.71	18.6
2	10.93	18.3
3	10.95	18.2
4	10.93	18
5	10.68	18
6	10.63	17.9
8	10.49	17.9
9	10.35	17.8
10	10.4	17.8
10.5	5.94	16.8
11	4.61	16.1
12	3.38	15.3
13	2.73	14.6
14	3.23	13.9
15	2.88	13
16	2.5	12.3
17.5	3.06	11.6
19	2.71	11.1
20	2.02	10.9
21	1.33	10.8
22.5	0.66	10.6
25	0.38	10.4
29	0.2	10.2

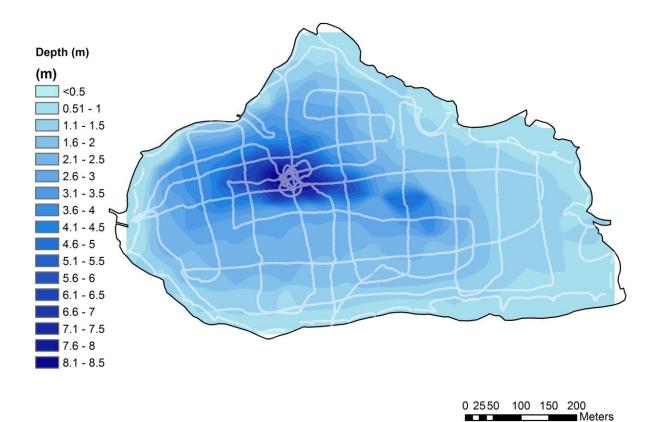
Figure 63 Bathymetric map of Llyn Nantlle Ucaf

The summary statistics for Llyn Nantlle Uchaf are given in Table 21. The lake has a mean depth of 2.02 m and reaches a maximum of 8.2 m towards the north-west side (Figure 63). With clear water and plants growing to a depth of 3.9 m in 2015, this approximates to 87% of the lake area available for colonisation (Figure 64), although in reality, not all areas of the lake bed between 2.9-3.9 m had plants present.

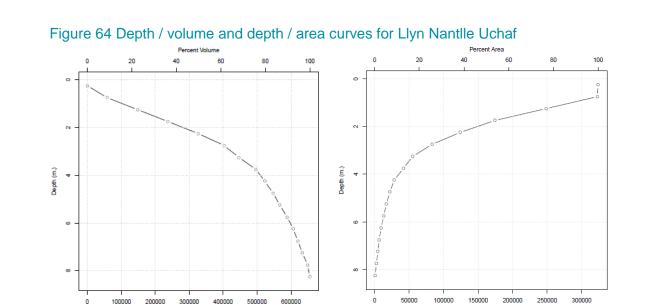
Bathy ID	WBID	Mean depth (m)	Max. depth (m)	Surface Area (m ²)	Volume (m ³)
b194	34099	2.023	8.21	323960	655367

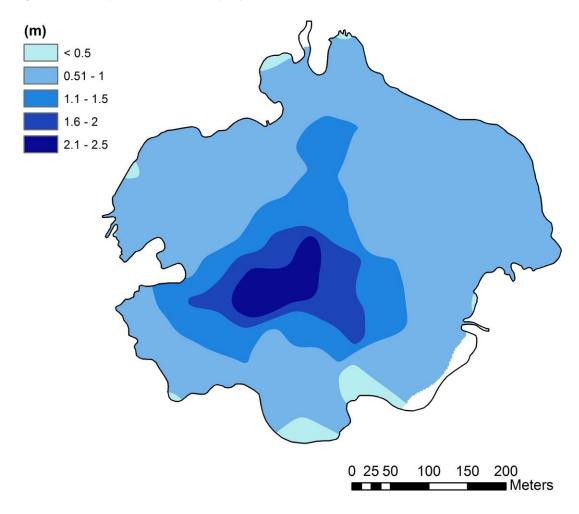
Figure 65 Bathymetric map of Llyn y Gader

Bathy ID	WBID	Mean depth (m)	Max. depth (m)	Surface Area (m ²)	Volume (m ³)
b195	34147	0.91	2.26	187852	171065

The data collation, processing and mapping was achieved using the standard techniques set out in Turner *et al.* (2011). Data archiving is detailed in Appendix 6.2
